**Flood Control Project Maintenance
Levee Inspections**
LMA District Cover Sheet
Spring 2017 Levee Inspection Results

Marysville Levee Commission

Spring 2017 Levee Inspection Results

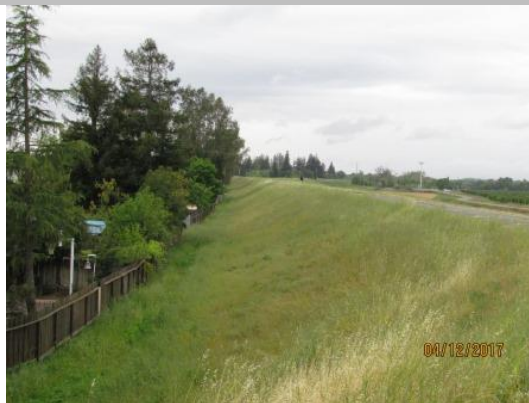
Photo 1 of 1 : SP_2017_NA0004_104_12_20170414_00023.jpg

LM Start	0.01	Rating **	M	Issue No.	12
LM End	3.19	Issue Type +	Ma	Location *	LS
Category	Earthen Levee			GPS Latitude/Longitude	
				Start	End
Item	Vegetation			39.149667 °	39.163847 °
				-121.601064 °	-121.560163 °
DWR ID	DWR_NA0004_01_s_2017_12				
Comment Code					
V1 : Control annual grass and weeds on the levee slopes and easements.					
Inspector Comment					
The crown shoulders have been mowed and sprayed but the slope annual grasses need to be maintained, Spring 2017.

View looking downstream of annual grasses, Spring 2017.

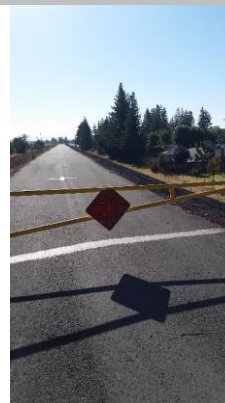
Photo 2 of 3 : UCIP_SP_2017_51917_75786.jpg

LM Start	1.99	Rating **	U	Issue No.	41
LM End	1.99	Issue Type +	En	Location *	LS
Category	Supplemental			GPS Latitude/Longitude	
				Start	End
Item	DWR UCIP Field Study			39.164957 °	39.164957 °
				-121.581832 °	-121.581832 °
DWR ID					
Comment Code					
Inspector Comment					
FS_ID:51917					
DS_ID:25467					
EP_NO: N/A					
Repair Type: Urgent					
Crossing Status: Not Found					
UCIP Comments: 6/29/2016 Per Frank Miller, LMA Contact, the					
USACE has identified an 8-inch gas line through levee. Unable to					
confirm owner, permit, or depth of crossing. (DWR UCIP - omagana)					
FIELD_STRUCT_DESC: 8-inch gas line of unknown material through					
the levee at an unknown depth.					
FS Date: 6/29/2016

View of levee crown where crossing goes through levee--no markers visible, photo 2 of 2.

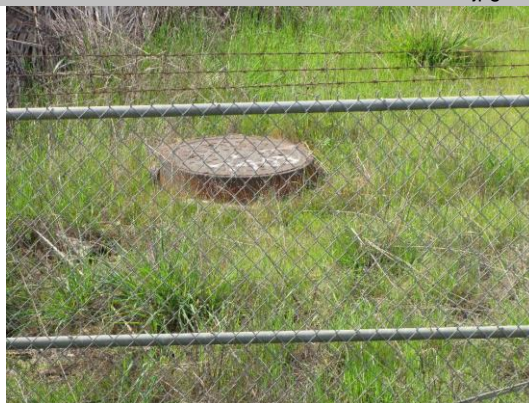
Photo 3 of 3 : UCIP_SP_2017_40935_69764.jpg

Manhole located behind fenced area on landward side.

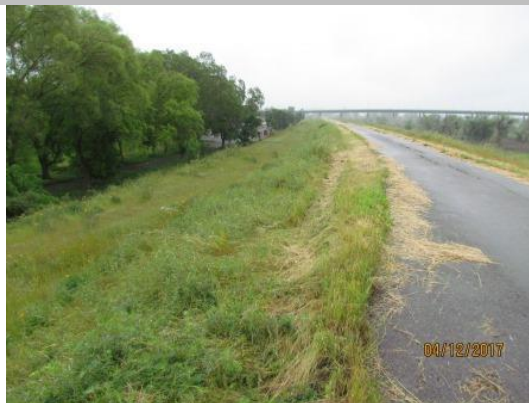
Photo 1 of 1 : SP_2017_NA0004_105_5_20170414_00017.jpg

LM Start	0.00	Rating **	M	Issue No.	5
LM End	1.23	Issue Type +	Ma	Location *	LS
Category	Earthen Levee			GPS Latitude/Longitude	
				Start	End
Item	Vegetation			39.149516 °	39.134731 °
				-121.601097 °	-121.594001 °
DWR ID	DWR_NA0004_02_s_2017_5				
Comment Code					
V1 : Control annual grass and weeds on the levee slopes and easements.					
Inspector Comment					
The crown shoulders have been mowed and sprayed but the slope annual grasses need to be maintained, Spring 2017.

View looking downstream of annual grasses, Spring 2016.

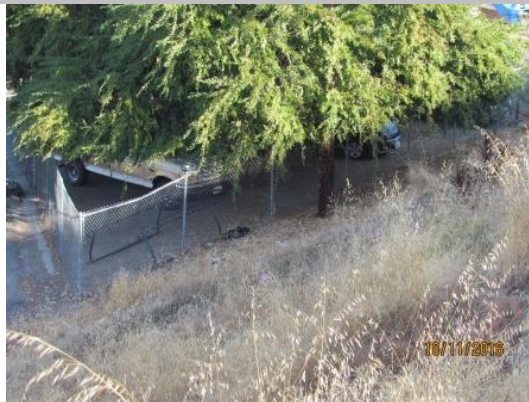
Photo 1 of 1 : SP_2017_NA0004_106_35_20170316_00015.jpg

LM Start	1.29	Rating **	M	Issue No.	35
LM End	1.33	Issue Type +	En	Location *	LS
Category	Earthen Levee			GPS Latitude/Longitude	
				Start	End
Item	Encroachments			39.145757 °	39.146233 °
				-121.581280 °	-121.580724 °
DWR ID	DWR_NA0004_03_f_2016_35				
Comment Code					
FE : Fence					
Inspector Comment					
Unpermitted fence encroaches on the levee toe.

View of fence on the landside toe.

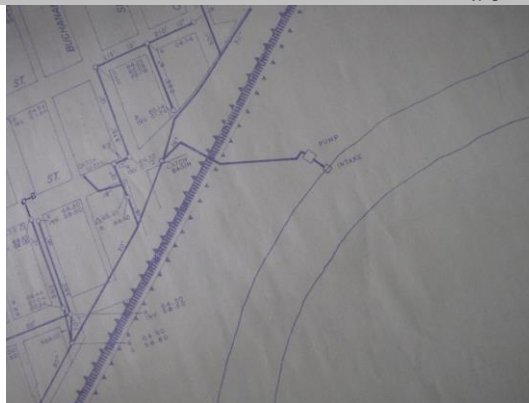
Photo 1 of 1 : UCIP_SP_2017_45363_17200.jpg

LM Start	1.60	Rating **	M	Issue No.	53
LM End	1.60	Issue Type +	En	Location *	LS
Category	Supplemental			GPS Latitude/Longitude	
				Start	End
Item	DWR UCIP Field Study			39.149063 °	39.149063 °
				-121.577190 °	-121.577190 °
DWR ID					
Comment Code					
Inspector Comment					
FS_ID:45363					
DS_ID:19142					
EP_NO: 7066					
Repair Type: Non-Urgent					
Crossing Status: Indicator Found					
UCIP Comments: Unable to take coordinates due to limited access to waterward side, used desk study coordinates.					
FIELD_STRUCT_DESC: 14-inch pipe through levee, 6 feet below levee crown. Discharges into Ellis Lake. Slant pump mounted on Metal Pump Stand located approximately 150 feet from waterward toe. (Permit No. 7066B, 7066A, 7066).					
FS Date: 3/14/2013

As-built dwg provided by Marysville Water Waste Treatment Plant.

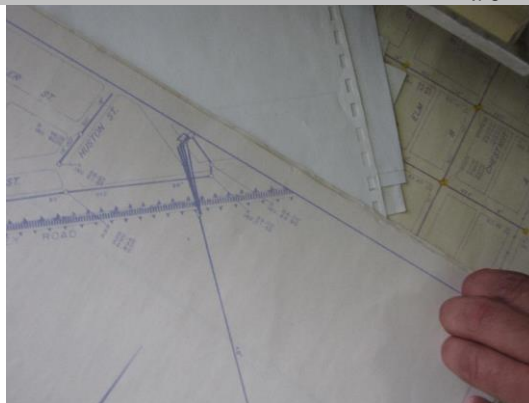
Photo 1 of 3 : UCIP_SP_2017_40999_69830.jpg

As-built provided by Marysville Water Treatment Facility.

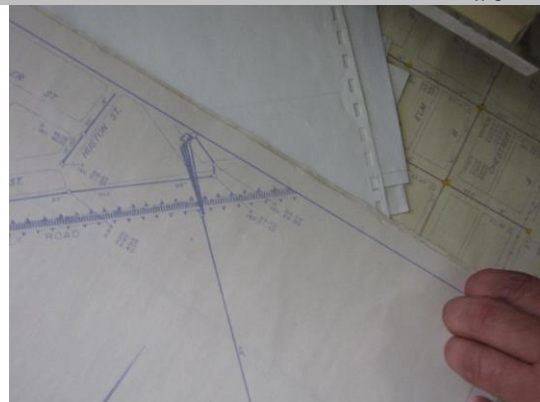
Photo 1 of 3 : UCIP_SP_2017_40998_69835.jpg

Comment Code					
Inspector Comment					
FS_ID:40998 DS_ID:19160 EP_NO: 2149 Repair Type: Non-Urgent Crossing Status: Indicator Found UCIP Comments: Depression observed on waterward toe filled with concrete rubble and riprap. Need to coordinate with City to determine records and extent of modifications if any. FIELD_STRUCT_DESC: 2 of 4: 17th & Howell Pump Station. 10-inch steel drain pipe, buried 15-feet below the crown. Runs parallel to other drainpipes, encased in concrete approx. 1-foot spacing. Pipe extends from storm water pump house to manhole (259 feet) north of landward toe. Flap gates and vent pipes at waterward toe. Discharges into concrete distribution box (3x4 foot). (Permit No. 2149-1956). FS Date: 3/14/2013

As-builts provided by Marysville Water Treatment.
